Standish, ME Route 114 and Route 35 Road Safety Audit Report

Virtual RSA meeting: 11/16/2020, Field review: 12/8/2020

Issued on: 05/28/2021

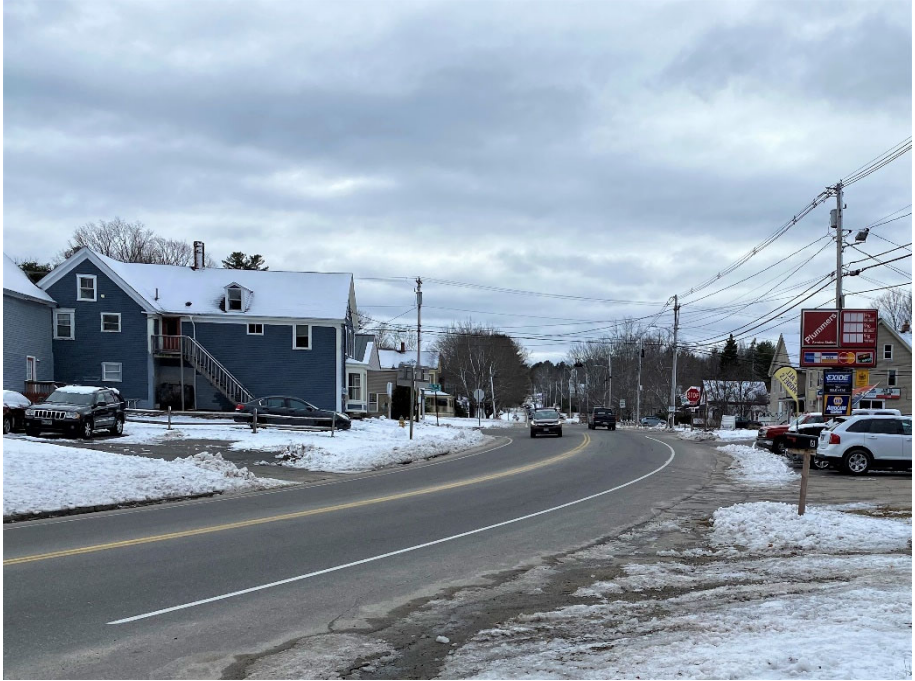
Specific Safety Concern	Suggested Improvements	Example of Issue
<ul style="list-style-type: none"> • Evening traffic can back-up for miles on the Route 35 southbound approach. Drivers are often impatient when they reach the intersection. • Morning traffic can back up for a mile on the Route 114 eastbound approach. Drivers are often impatient when they reach the intersection. 	<p>Intermediate Range –</p> <ul style="list-style-type: none"> • Replace the intersection four-way stop control with an adaptive traffic signal. The design master plan for Sebago Lake Village determined, in December of 2012, that this intersection warrants a traffic signal.

<p>Route 35 southbound approach.</p>

An adaptive traffic signal will provide both safety and operational benefits to the area. The largest potential safety improvement of this treatment (19-percent reduction) applies to angle crashes.

Given the safety and site needs at this intersection, the best opportunities for improving safety include installing an adaptive traffic signal. According to a study previously conducted in this area, this intersection warrants a traffic signal.

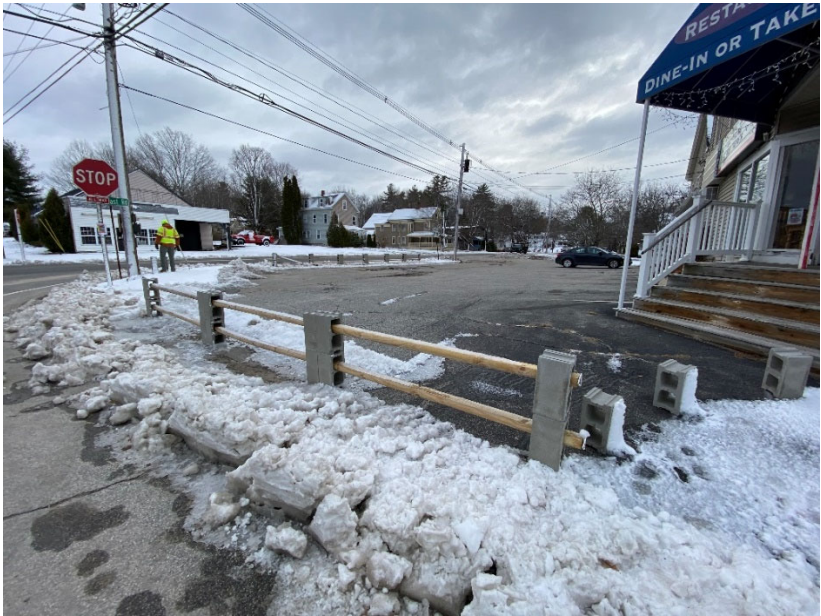
Specific Safety Concern	Suggested Improvements	Example of Issue
<ul style="list-style-type: none"> There are intermittent sidewalks and no crosswalks throughout the study area for pedestrians. With only intermittent facilities available, pedestrians resort to walking in the shoulder through this area, putting them at higher risk for being struck by a motorized vehicle. 	<p>Intermediate Range-</p> <ul style="list-style-type: none"> Include sidewalks and crosswalks at this intersection. However, there is noted resistance from the town to include pedestrian facilities.

<p>Southeast corner of Route 35 and Route 114, no sidewalk, pedestrian ramp, or crosswalk present on this corner.</p>

Although there are no CMFs for sidewalks, studies have found that installing sidewalks can result in a 65-89 percent reduction in crashes involving pedestrians walking along roadways. Installing high visibility (e.g., ladder, continental, zebra) may reduce vehicle/pedestrian crashes up to 40 percent.

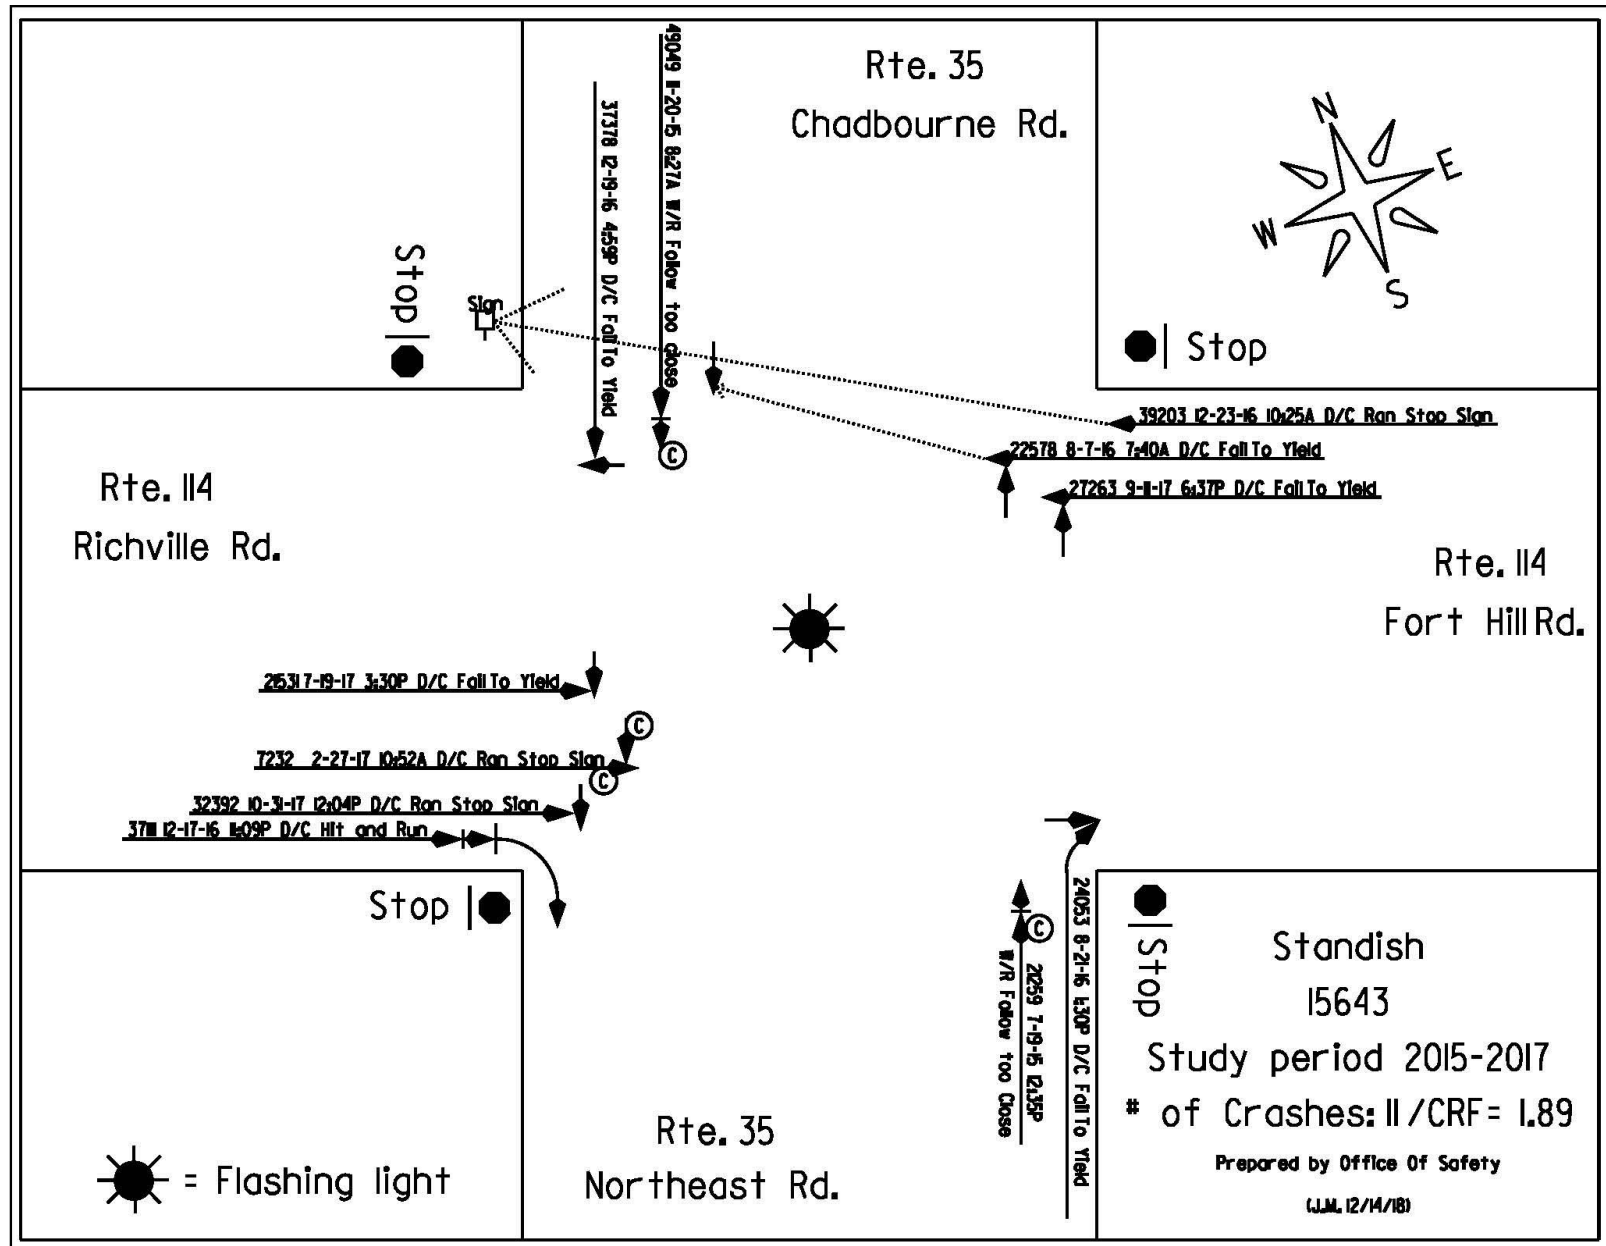
Intersection of Route 114 and Route 35

There were 17 crashes at this intersection. The crashes are relatively evenly split among the intersection approaches with two to four occurring on each. Many of the crashes (8 of the 11) at this intersection are failures to yield and running the stop sign.

As noted by the municipality, if volumes are high and traffic backs-up for a mile, driver's are likely impatient by the time they reach the intersection and do not wait their turn or run the stop sign. There are also numerous driveways near the intersection that drivers could use to bypass the intersection.

- Add turn lanes for heavy-demand movements.
 - Potentially use PACTS Miovision to determine movement patterns.
- Consider alternative intersection controls such as a roundabout or a traffic signal. A roundabout would help with both efficiency and safety, but may require right of way impacts. Right-turn bypass lanes could be incorporated, depending on right-turn demand.
- Consider access management options for the driveways near the intersection, like better driveway definition, more narrow entries and exits, and combining/consolidating driveways.
