Standish, ME Route 114 and Route 35 Road Safety Audit Report

Virtual RSA meeting: 11/16/2020, Field review: 12/8/2020

Issued on: 05/28/2021

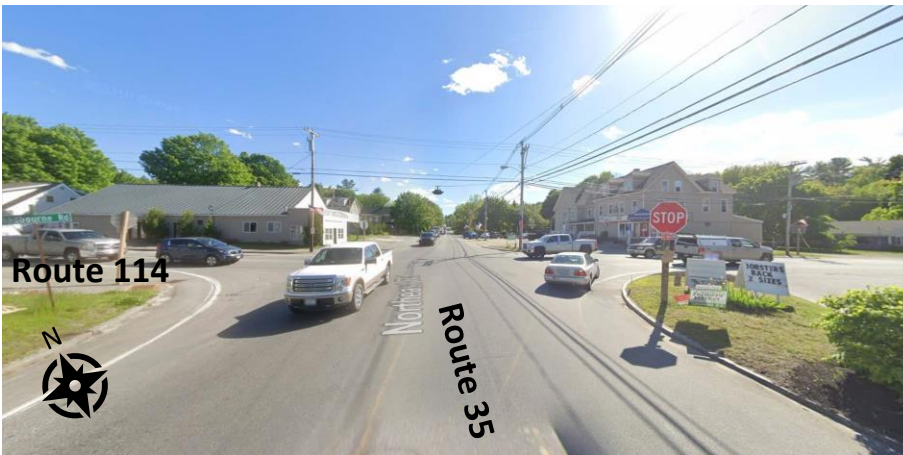
Street view of intersection at Route 114 and Route 35 traveling South on Route 35, from Google Maps

There were 17 crashes at this intersection. The crashes are relatively evenly split among the intersection approaches with two to four occurring on each. Many of the crashes (8 of the 11) at this intersection are failures to yield and running the stop sign.

As noted by the municipality, if volumes are high and traffic backs-up for a mile, driver's are likely impatient by the time they reach the intersection and do not wait their turn or run the stop sign. There are also numerous driveways near the intersection that drivers could use to bypass the intersection.

- Add turn lanes for heavy-demand movements.
 - Potentially use PACTS Miovision to determine movement patterns.
- Consider alternative intersection controls such as a roundabout or a traffic signal. A roundabout would help with both efficiency and safety, but may require right of way impacts. Right-turn bypass lanes could be incorporated, depending on right-turn demand.
- Consider access management options for the driveways near the intersection, like better driveway definition, more narrow entries and exits, and combining/consolidating driveways.

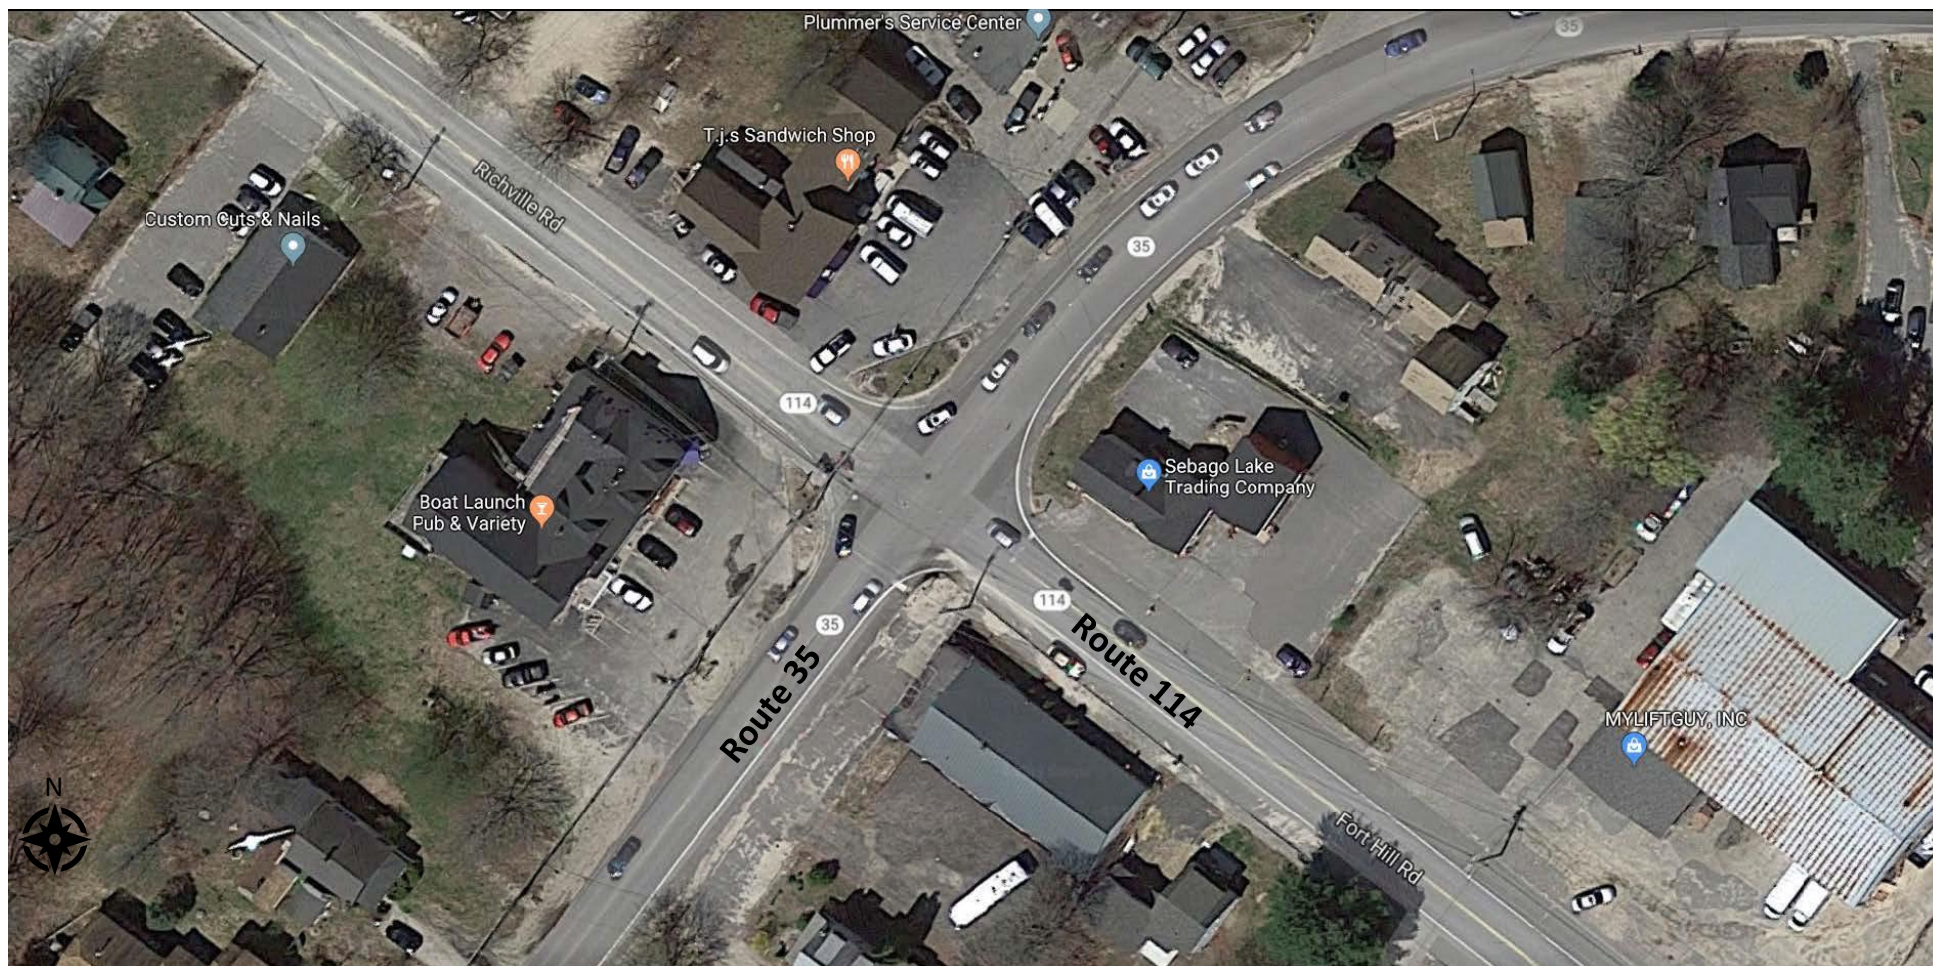
Aerial view of Route 35 and Route 114, from Google Maps
